BRIXTON WINDMILL

London Borough of Lambeth

An Historic Building Survey

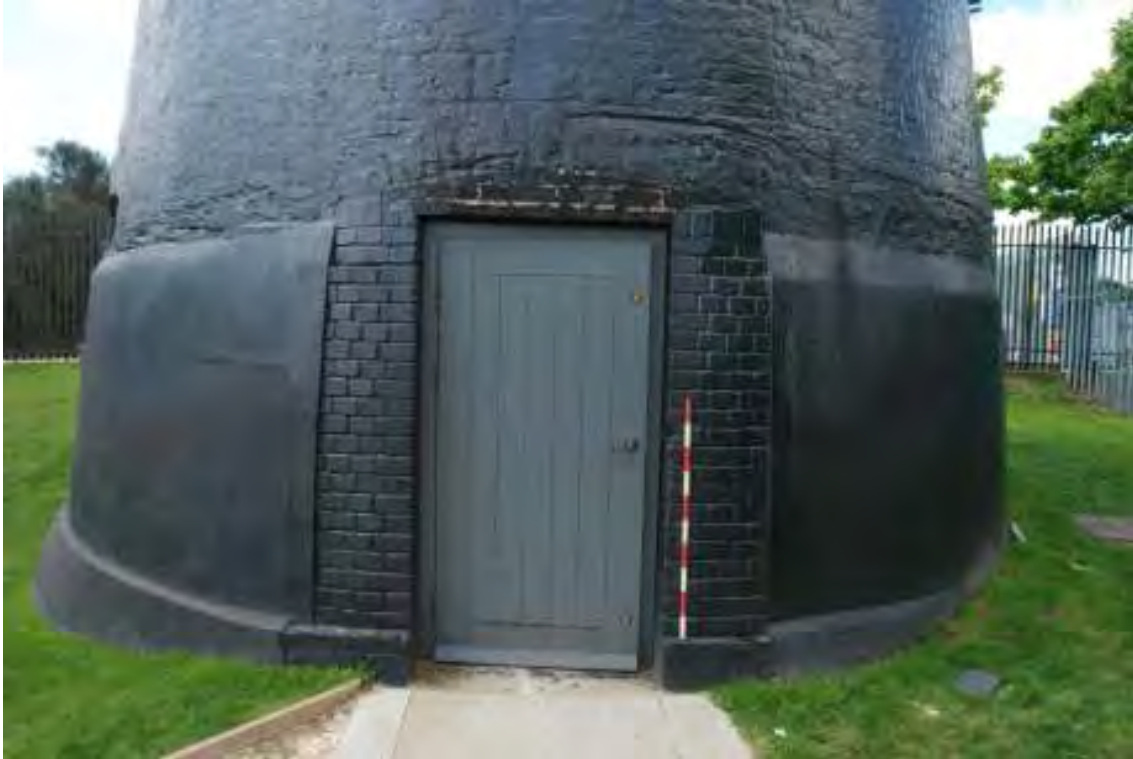
The base of the structure projects out (by 50mm from the main mill body). This is covered by a thicker layer of tar (c.150mm thick). This covers two steps out in the brickwork, one at the level of the present door threshold, and one c.1.5m above this. This additional layer of tar may have been added during the restoration works to protect the structure's base. The step-outs in the brickwork are presumably original, and help support the structure.

Fig. 31: Photograph of the bottom part of the mill structure (around the present door), showing the additional protective layer of tar, covering two 'steps out' in the base.

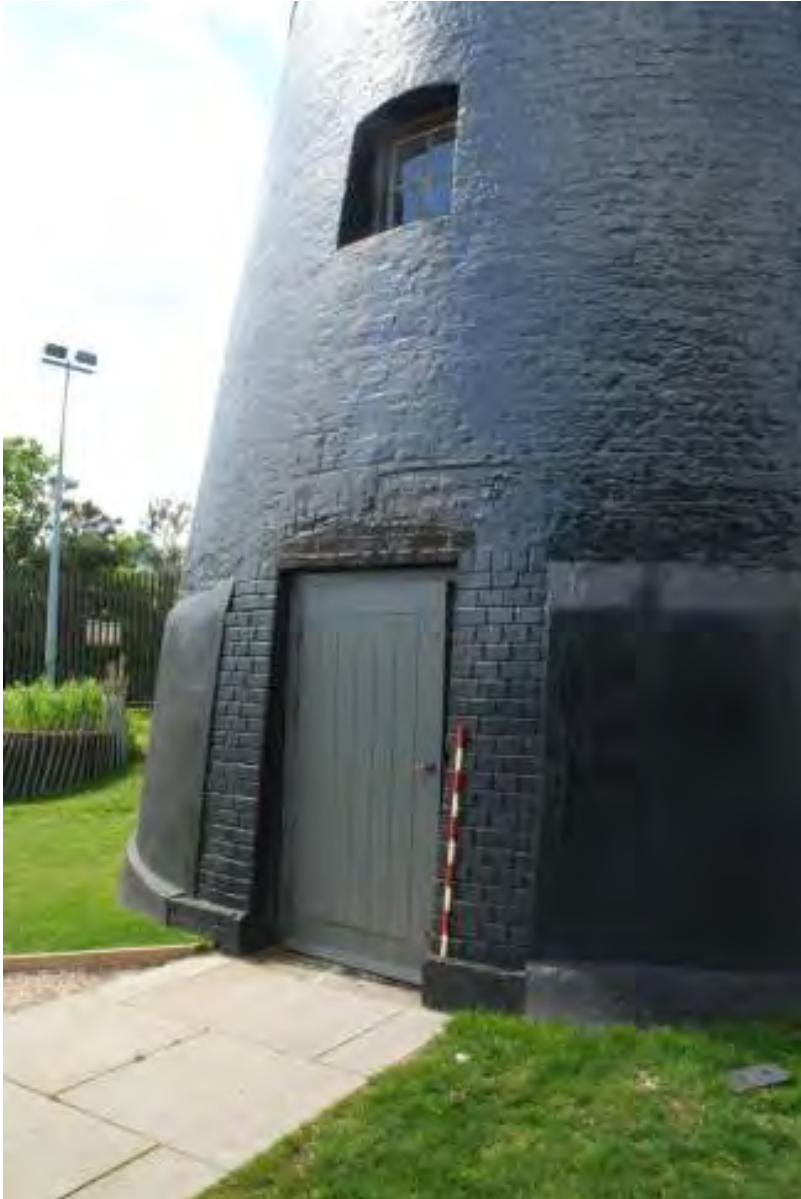
The present front door is not original, as it is made of modern wood and surrounded by modern patched brickwork. It measures 1.05m in width by 2.15m in height.

Fig. 34: Photograph of the present door into the mill.

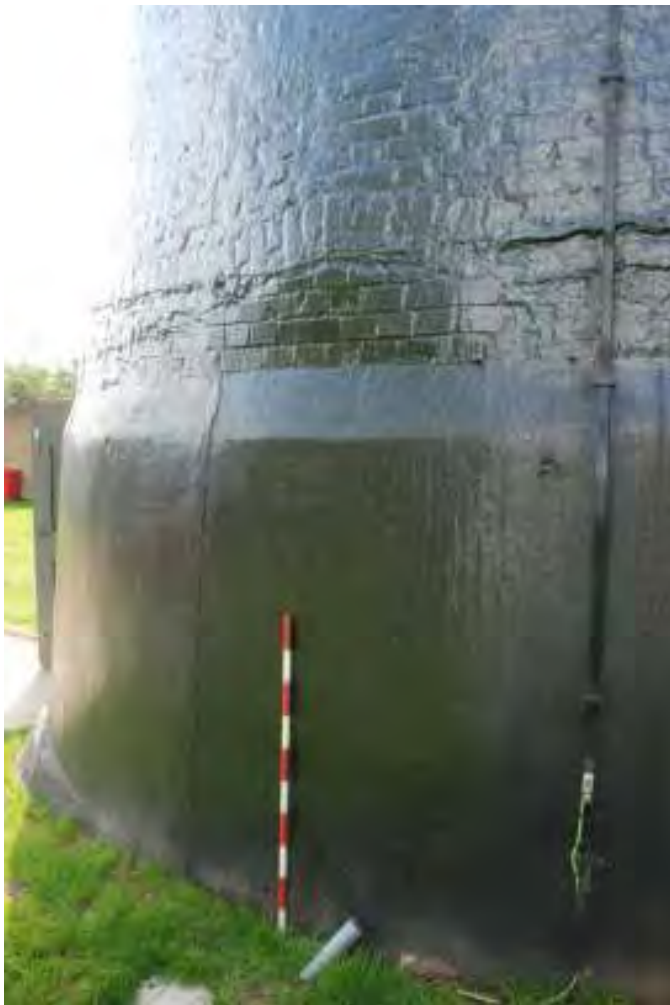
Field observations identified one blocked door on the northern side of the structure (*c.*3m north-west of the present door) (fig.36). It measured 0.95m in width and *c.*2.2m in height, including a soldier course of brickwork. Another possible door was observed on the south-eastern side, just to the south of the present doorway, where an indented arch (measuring 0.9m in width, 0.38m in height, and indenting into the structure for *c.*0.3m) was observed (fig.37). This was positioned *c.*1.87m above ground-surface, and had a soldier course on top (making the door *c.*2.25m in total height). Alternatively, the present door may be located in the same position as an earlier door, as the remnant of an older soldier course (0.22m in height) was observed above the door (fig.34). The modifications to the structure over the years means that it is tricky to provide a definitive answer as to where the original door, or doors, were.

Fig. 36: Photograph of the blocked-up doorway on the northern side of the mill, at ground-floor level.

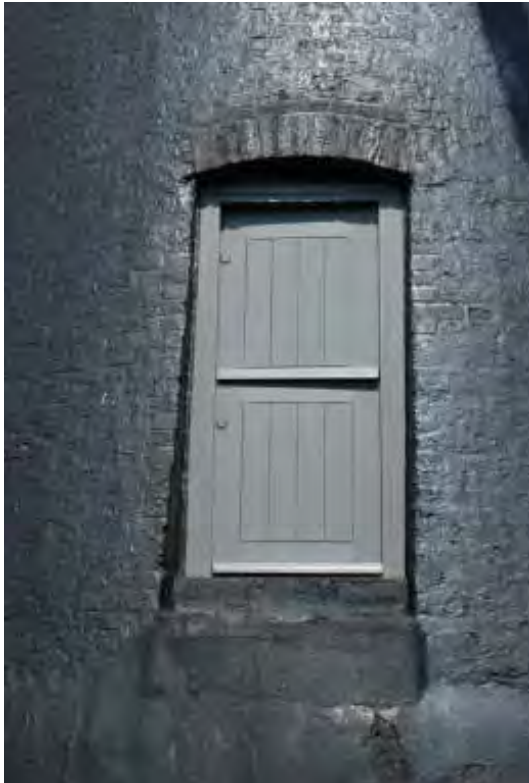
Although the first-floor door on the southern side of the structure is replaced, the doorway is original, with no indication of patched brickwork or it being cut through at a later date. The original overlying soldier course is also visible (fig.38).

Fig. 38: Photograph of the southern door at first-floor level.

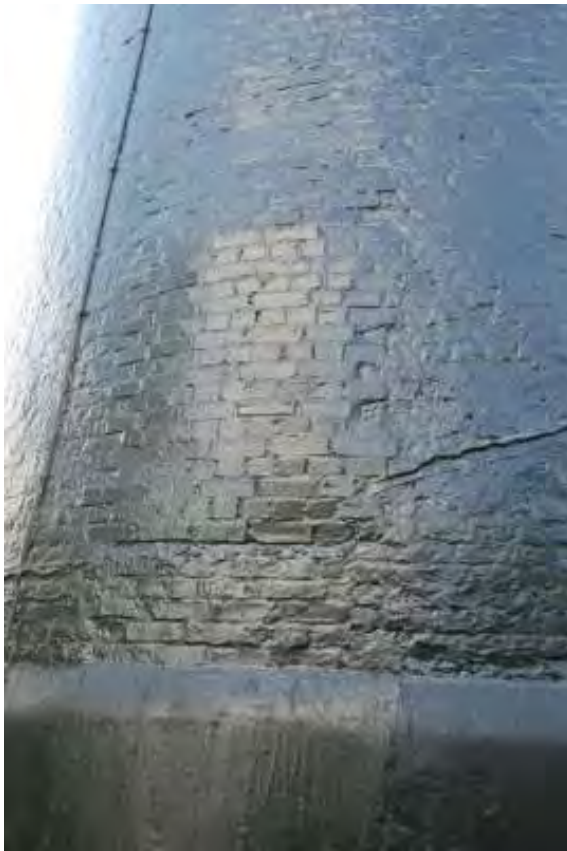
There would have been a corresponding door at this level on the northern side. This was clear from the interior (see section 6.5). From the exterior, an area of patched bulging brickwork was observed in this area (fig.39).

Fig. 39: Photograph of the patched-up brickwork indicating the location of the blocked-up doorway at first-floor level on the northern side of the structure.

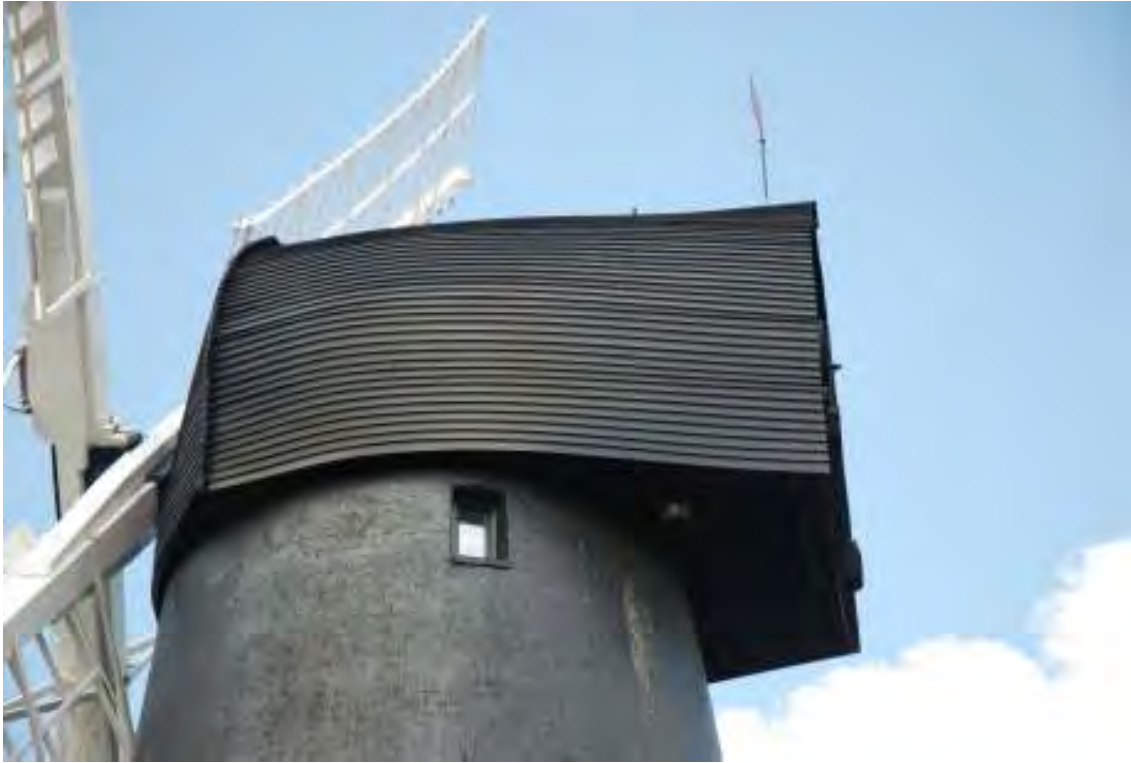
The cap is a brick structure, timber-framed and weather-boarded, which sits on top of the main mill body. It was not possible to measure it, however is believed to be *c.* 3m high. It was removed and repaired in 2010, with the weatherboarding (visible from the exterior) being completely replaced at this date.

Fig. 43: Photograph of the cap today.

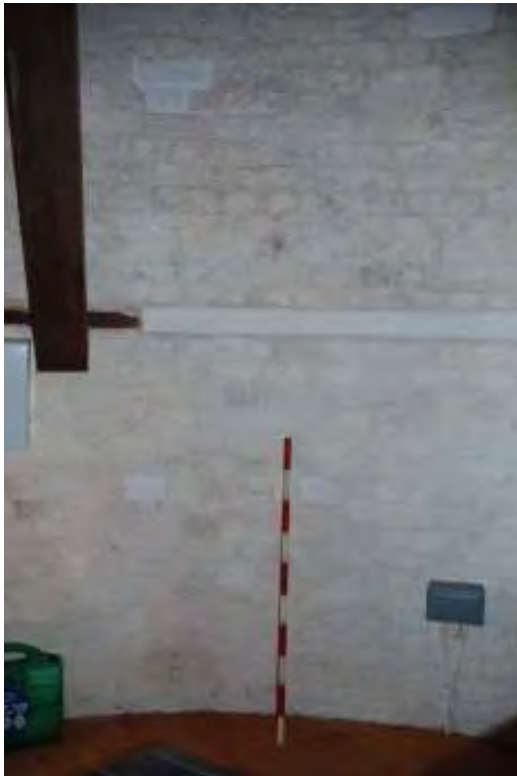
The brickwork has been restored in places, with some completely replaced bricks (fig.55). This was done during the 2010-11 restoration works, to further strengthen the structure.

Pieces of horizontal timber were observed on all floors (1-1.5m above floor levels), running the whole way round the structure, instead of a brick course (fig.55). These are original, and were presumably inserted to ensure the brickwork remained level.

Fig. 55: Photograph of the interior of the windmill, showing the horizontal pieces of timber (above the scale), and occasional replaced bricks.

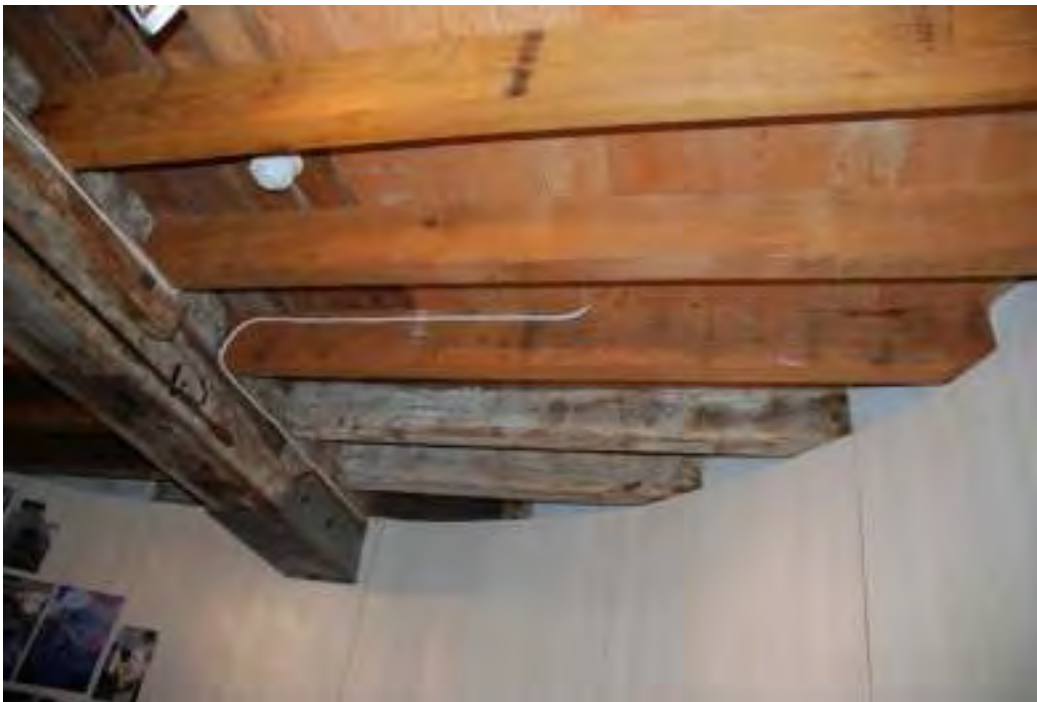
Many of the floorboards have been replaced with modern machine-cut wood (some in 1964 and some in 2010) (fig.56). Many of the ceiling beams were also replaced, although some original beams do survive (they are mentioned in the discussion below).

Fig. 56: Photograph of the ceiling beams and floorboards, looking up from the ground-floor. The beams and floorboards inserted during the 2010 renovation works are visible (orange coloured) plus those inserted in the 1960s (far end of frame).

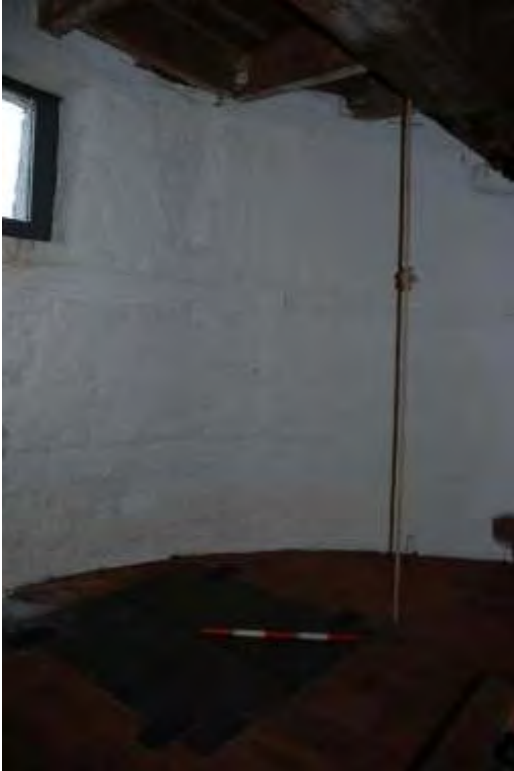
The trapdoors, found on all floors and measuring $c.0.8\text{m} \times 0.8\text{m}$, are also later insertions, built into the modern floorboards (fig.59). Further evidence for them not being original existed on the third floor, where empty mortice-holes were observed in the north-south timbers directly beneath the trapdoor, suggesting that an east-west beam must have originally been where the current trapdoor is (fig.60). Unfortunately, no evidence for the position of the original trapdoors was noted, mainly because the floorboards had been replaced. It seems likely that they would have been located away from the machinery and chutes - possibly towards the southern end of the structure?

Fig. 59: Photograph of the trapdoors on the third floor (one in the floor and one on the ceiling) - both replaced.

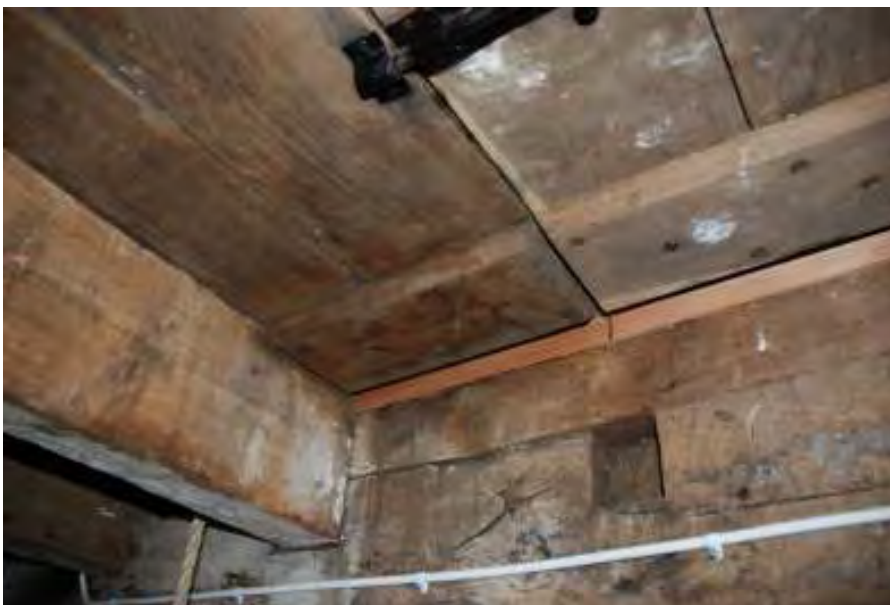
Fig. 60: Photograph of the trapdoor in the ceiling of the third floor, with the empty mortice hole directly beneath it, showing that there had once been an east-west beam here and that this was not the original location of the trapdoor.

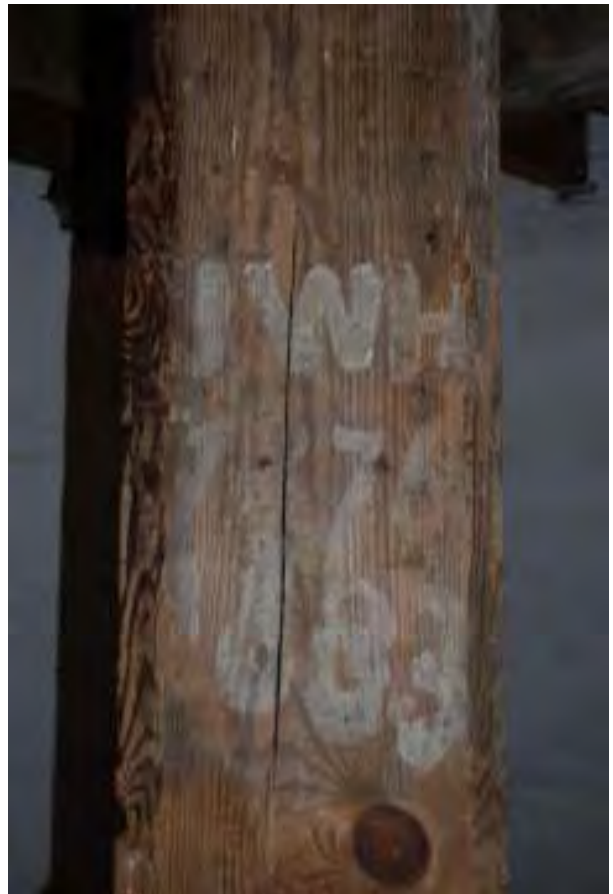
Fig. 68: Photograph of the whitewashed graffiti observed on the central vertical shaft, proving that this shaft was original to the mill.

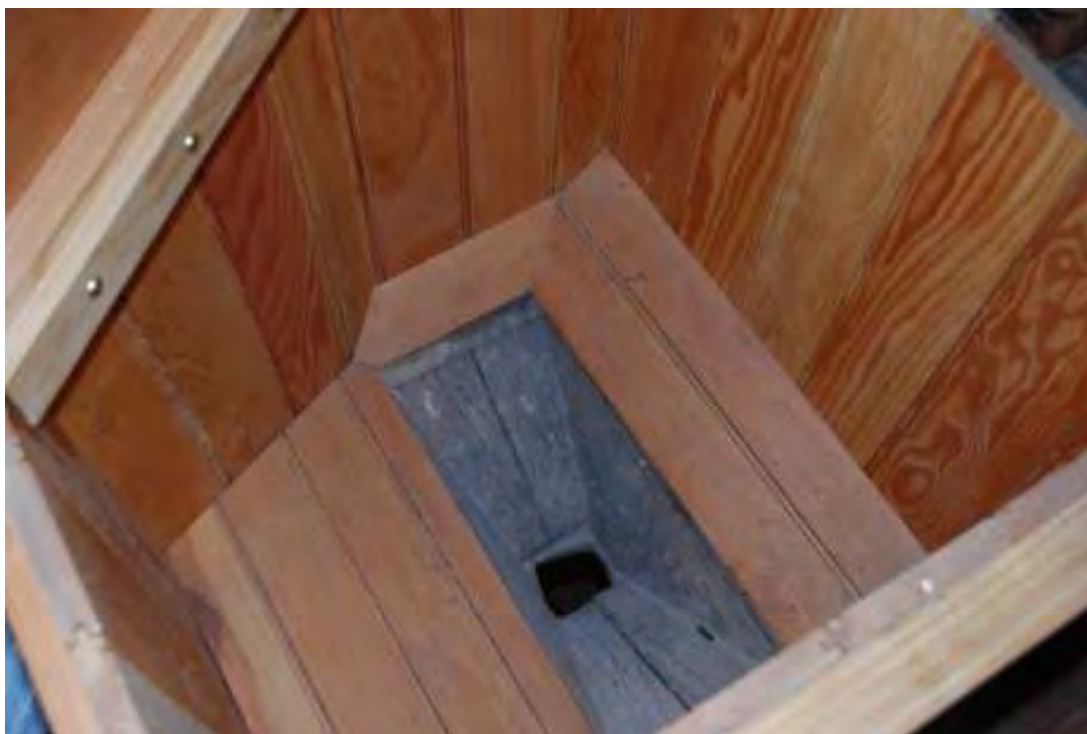
Two chutes, leading to the floor below and both enclosed within modern wooden boxes, were observed in the north and north-east corners of this floor. The northern chute is modern (made of machine-cut wood), however the north-eastern one looks older, based on the type of wood (fig.76-77). These chutes transferred the ground meal to the floor below.

Fig. 76: Photograph of the wooden chute in the north-east corner of the second floor, possibly original.

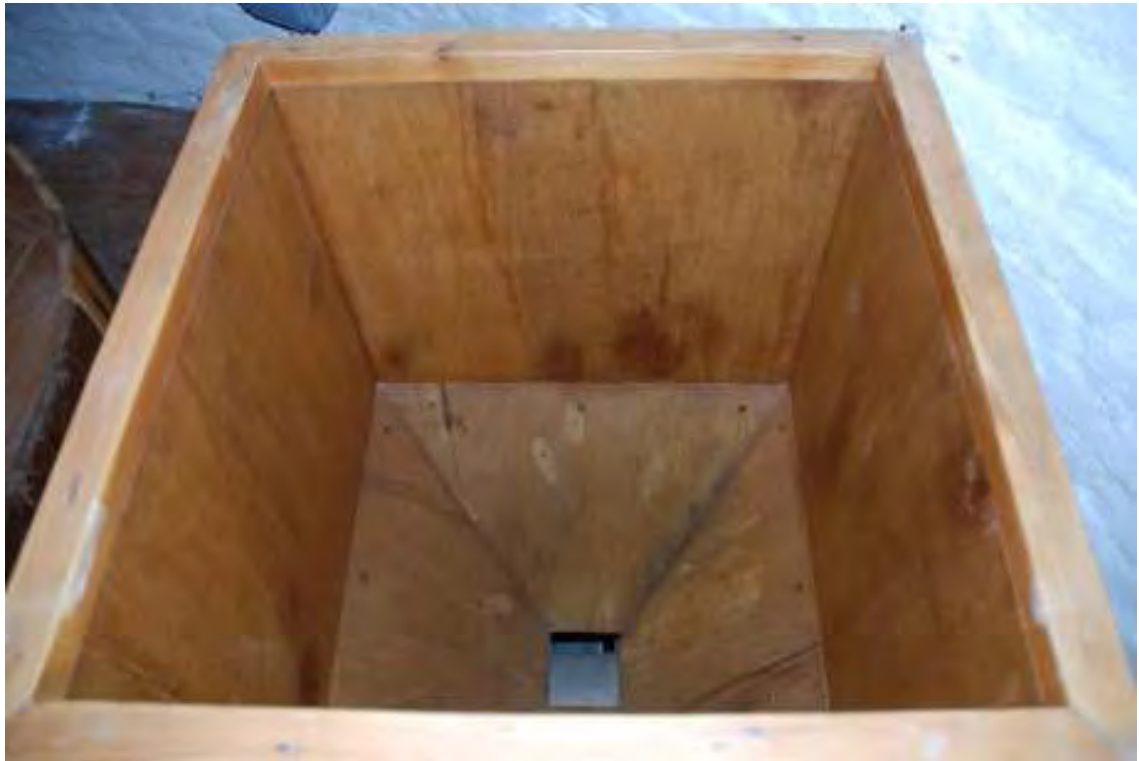
Fig. 77: Photograph of the wooden chute in the northern side of the second floor, not original.

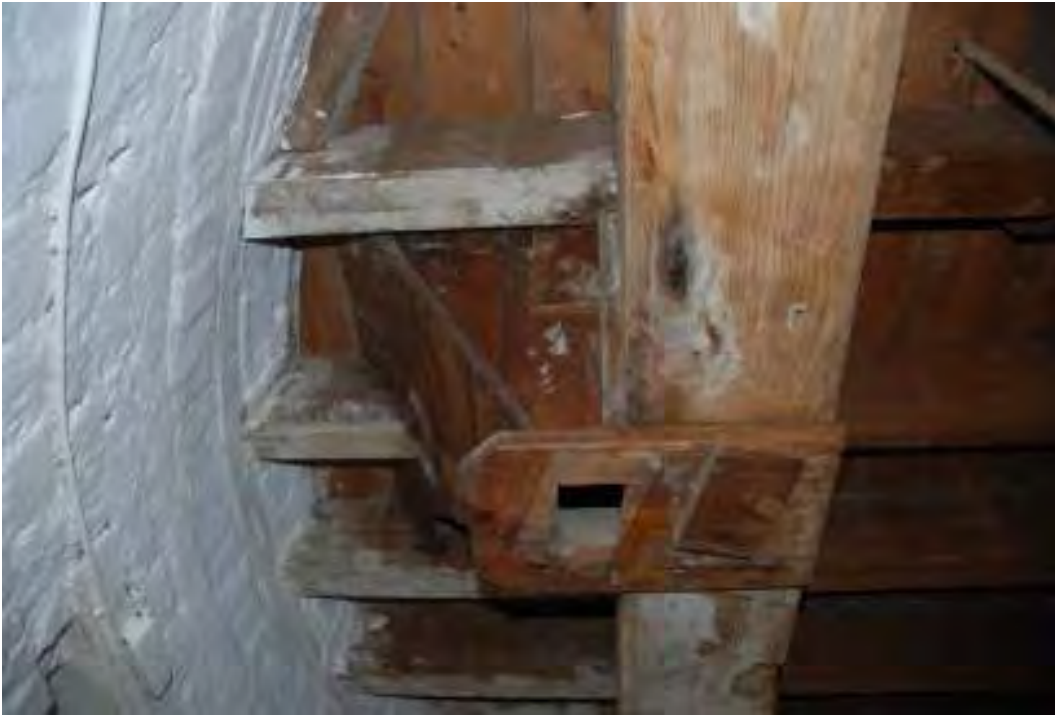
Some original features relating to the mill's wind-powered days were observed, and suggest that there may originally have been two pairs of millstones. A wooden chute was observed towards the north-eastern end of the structure, on the ceiling leading from the floor above. This was attached to a square wooden base-plate (measuring 0.23m x 0.4m), which was attached to the original east-west ceiling beam (fig.78). This chute is not currently attached to any other mechanism, suggesting that it is original and not inserted during the restoration works. No corresponding chute was observed on the opposite side of the structure, however a similar square wooden base-plate (measuring 0.22m x 0.38m) was observed on the north-eastern side, suggesting that there may have originally been a similar chute here (fig.79). This suggests that there may have been two sets of mill-machinery, either side of the mill, and that the two wooden chutes fed into one each. The fact that there are two chutes leading to the floor below (with the southern one looking original), supports this. It was relatively common for mills to have more than one set of millstones, as this was energy-efficient.

Fig. 78: Photograph of the wooden chute on the north-eastern side of the second floor, leading down from the third floor.

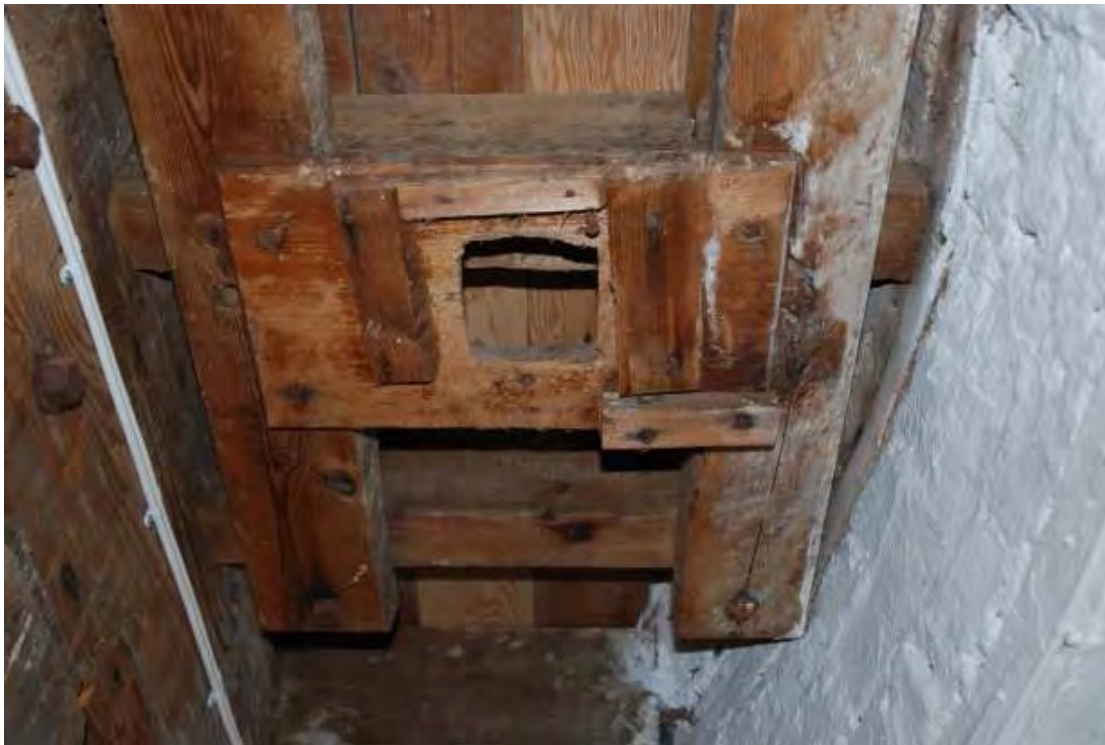
Fig. 79: Photograph of the square base-plate, on which a chute was presumably once attached, on the north-western side of the structure.

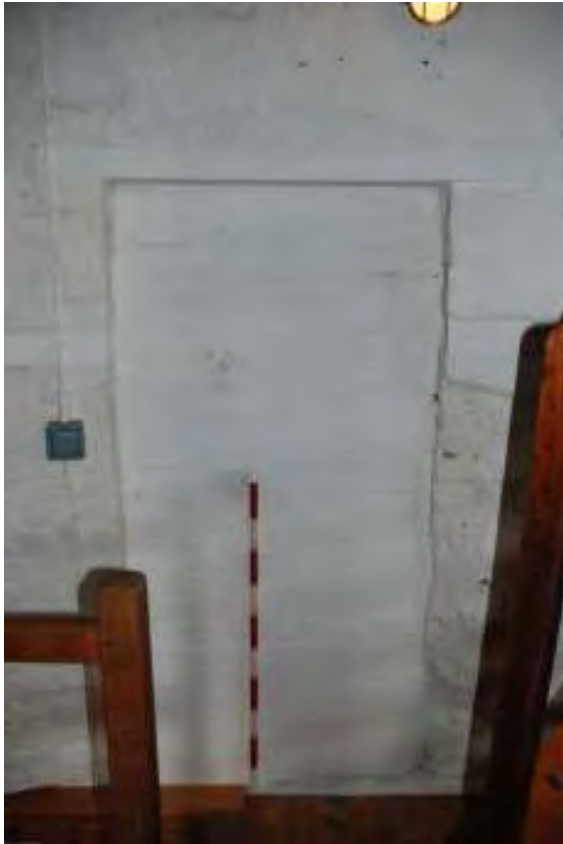
Fig. 81: Photograph of the blocked doorway on the northern side of the structure.

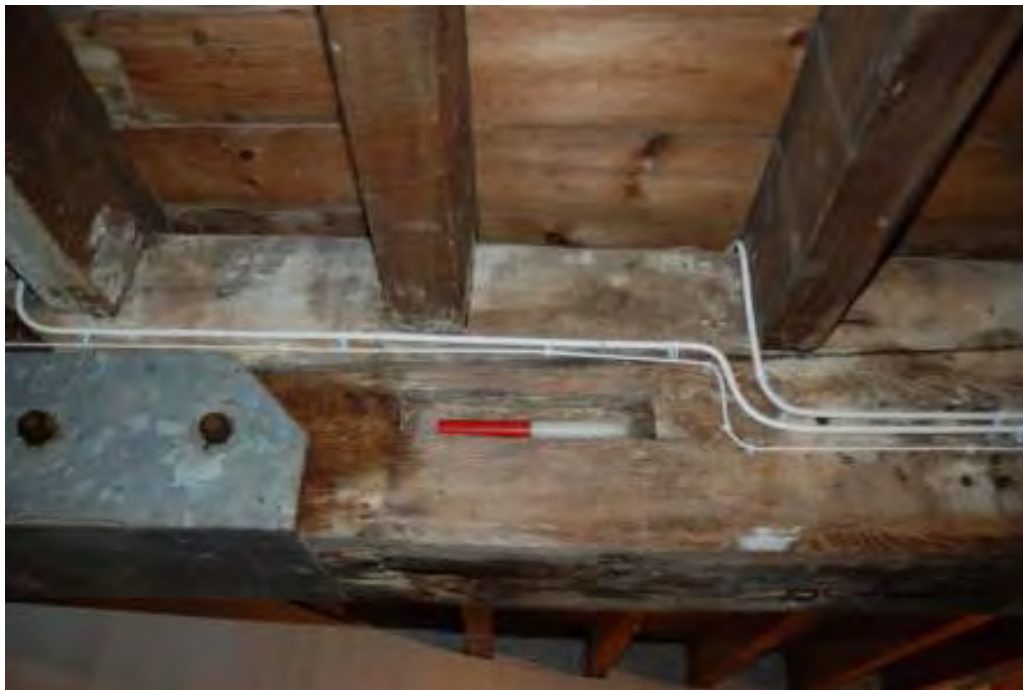
Although many of the ceiling timbers are modern (as is the central wooden post), the main north-south beam (4.92m in length) may be original, as looks older than many of the other timbers. Furthermore, empty mortice-holes were observed along its eastern and western sides, suggesting that it may be an earlier timber which was reused in the mill's construction (fig.93). It has been suggested that some of the mill's timbers may be older ships timbers.

Fig. 93: Photograph of the main east-west beam on the ground-floor, with an empty mortice hole suggesting that this may be a reused beam.

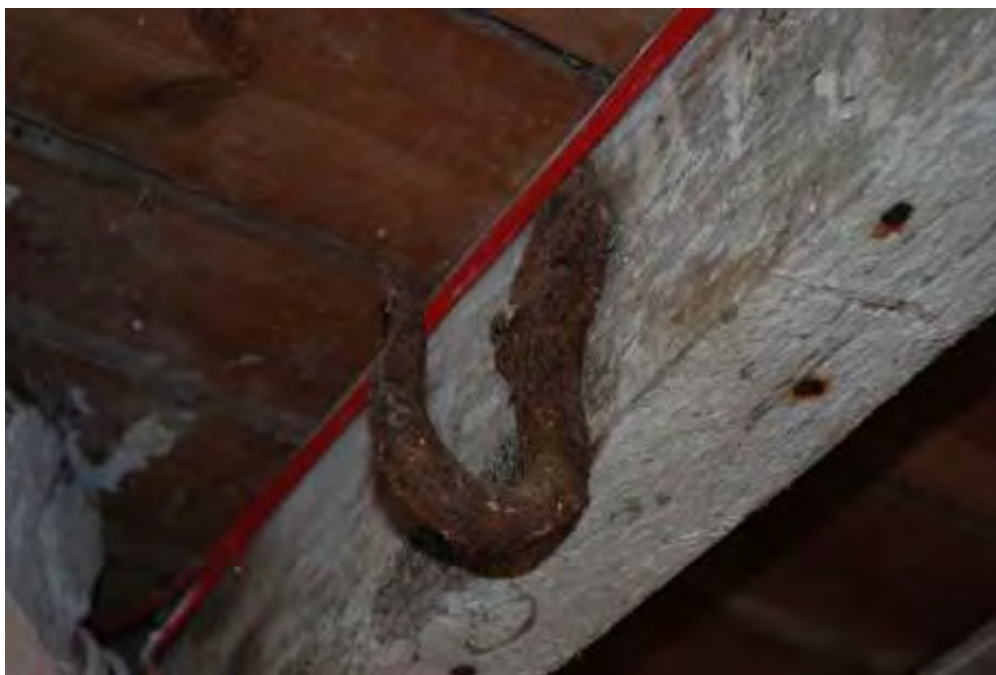
An iron hook was observed hanging off one of the older beams just to the north of the door (fig.94). This is presumably an older feature, not inserted during the renovation works, as it is hidden out of the way. Sacks of grain presumably hung off this, either when the mill was first working or when it was used for storage. Similar hooks were probably once found all over this floor, as is suggested by Rex Wailes in his 1958 report.

Fig. 94: Photograph of the iron hook observed hanging off one of the ceiling beams on the ground-floor.
