BRIXTON WINDMILL

London Borough of Lambeth

An Historic Building Survey

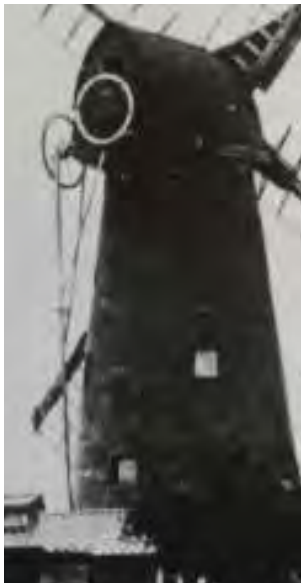
The cap (to which the sails are attached) can rotate, to make the sails face into the wind. This is the difference between a post-mill (where the whole mill rotated), and a tower-mill (where only the cap rotated). This was achieved, at Brixton, using a wheel-and-chain arrangement, not a fan-tail. A wheel (positioned on the side exterior of the cap) was attached to a chain, which led to the first-floor stage, from where the cap could be rotated. This is depicted in historic images, such as the pre-1862 photograph (fig.45). This wheel was removed in 1864, alongside the sails.

Fig. 45: Extract from a pre-1862 photograph, clearly showing the two wheels which could be operated from the first-floor stage. The one directly at the rear of the cap operated the patent sails (through the striking rod system taken through the windshaft), and the one to the left of this rotated the cap (from Greater London Council 1967 pamphlet).

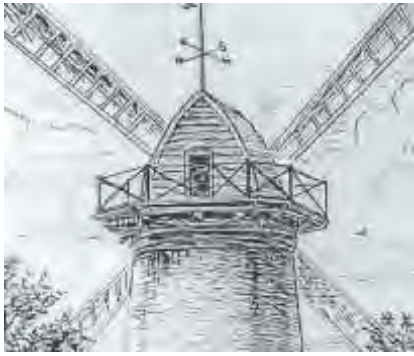
When the sails were removed, a gallery, running around the base of the cap, was added. This is depicted in images from this period (fig.46). It was, however, removed during the 1964 renovation works, and no evidence for it survives.

Fig. 46: Extract from a c.1880 image of Brixton Windmill, clearly showing the gallery inserted around the base of the cap (Lambeth Archives, Landmark).

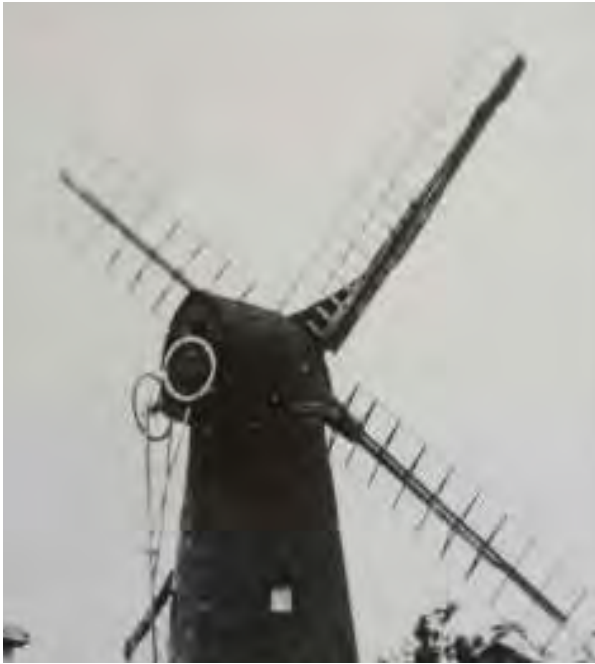
Brixton Windmill has four sails - two patent sails and two common sails. These are, however, replicas installed during the 1964 renovation works (the originals were removed in 1864). They are made from imported pine timber, and their design is based on pictorial depictions of the original sails (fig.48). Unfortunately it was not possible to measure them, however they are believed to be c.15m long.

Fig. 48: Extract from a pre-1862 photograph showing the two different types of sails. The top right sail is a patent sail; the top left and bottom right sails being common sails (from Greater London Council 1967 pamphlet).

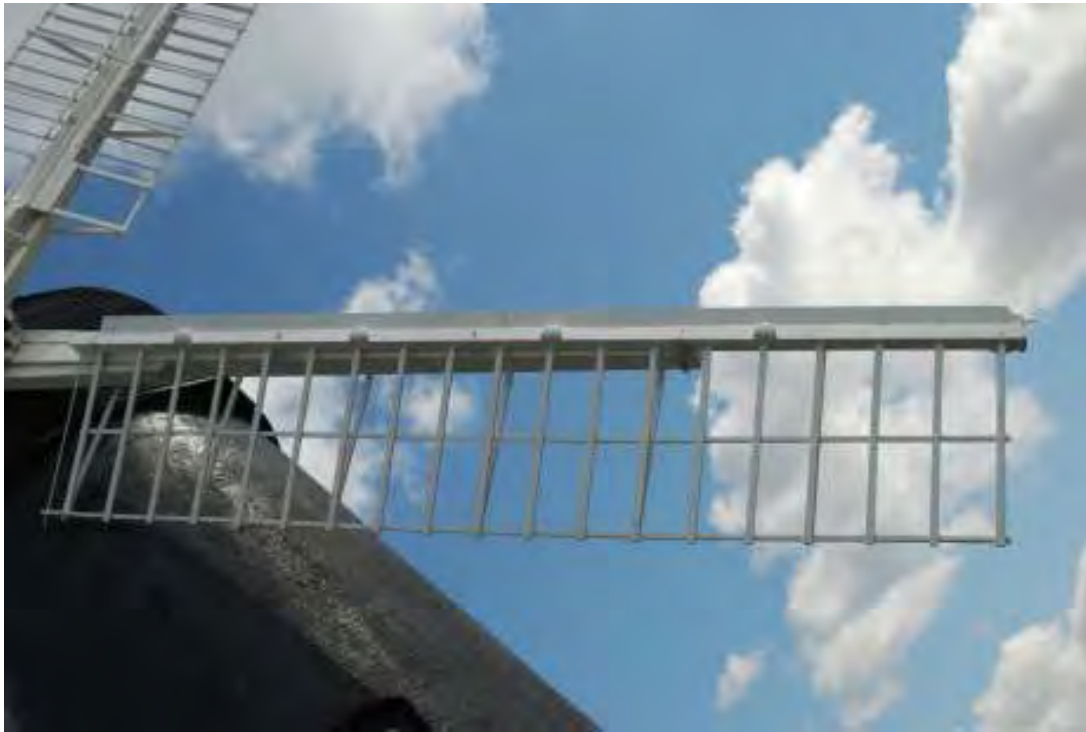
New versions of both types of sails have been made. The common sails do not have the attached cloth, although the fittings where it would have been attached are visible (fig.49). The patent sails have the wooden shutters (fig.50) which can still be opened and closed, using the long winding rod mechanism stored on the ground-floor, connected to a fixing at the end of the sails, as was seen in action (fig.51). The other method of operating the patent sails (the striking rod running out to the wheel-and-chain mechanism, which could be used whilst the sails were moving), is not operational today.

Fig. 49: Photograph of one of the 'common sails' today. The attachments to which the cloth could be attached to (the round fittings) can be seen.

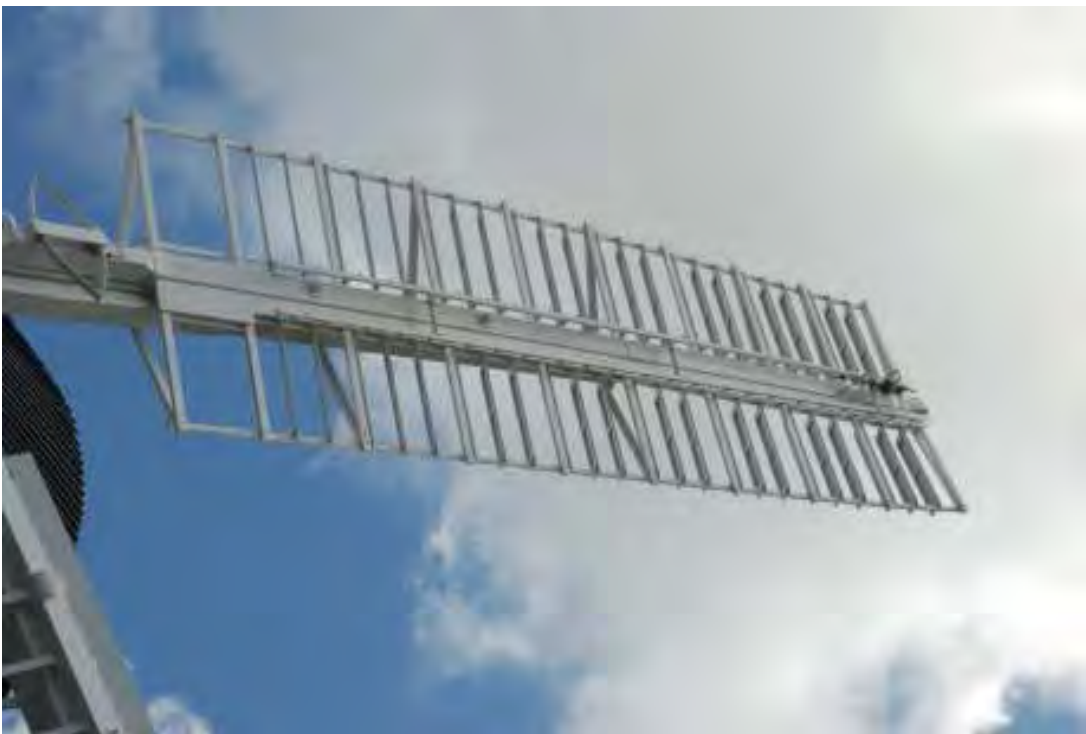
Fig. 50: Photograph of one of the 'patent sails' today. The wooden shutters, which were opened and closed dependent on the wind, can be seen.

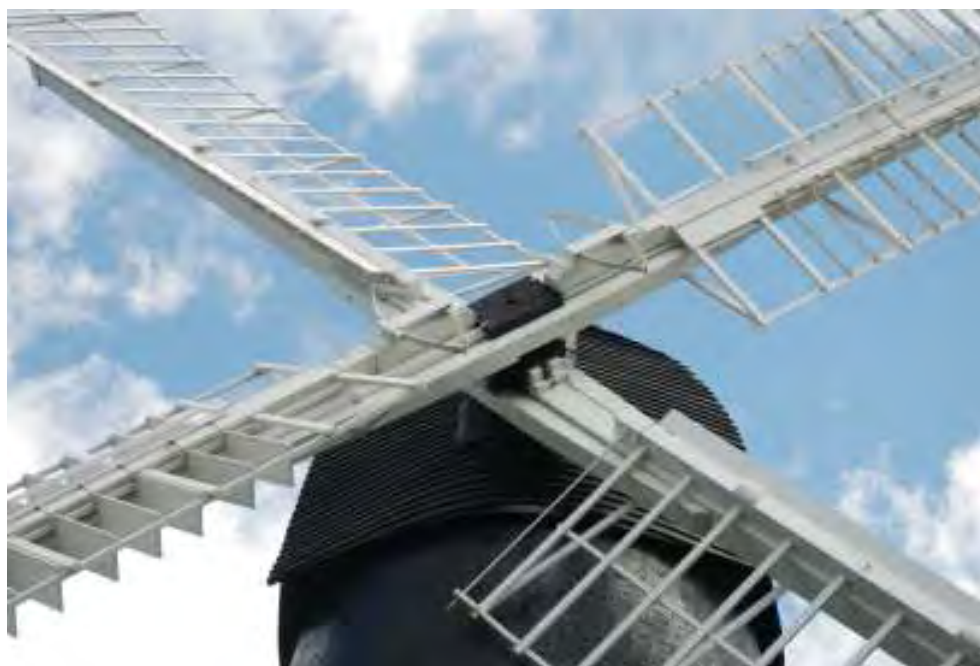
The sails are fastened on to large timbers (called 'stocks') which pass through the iron frame (the 'canister' or 'poll-end') on the end of the windshaft, carrying the drive into the cap (fig.52). Clamps are currently attached to the stocks to ensure they can withstand the wind (these are not original).

Fig. 52: Photograph of the central part of the sails, showing the stocks and central 'canister'.

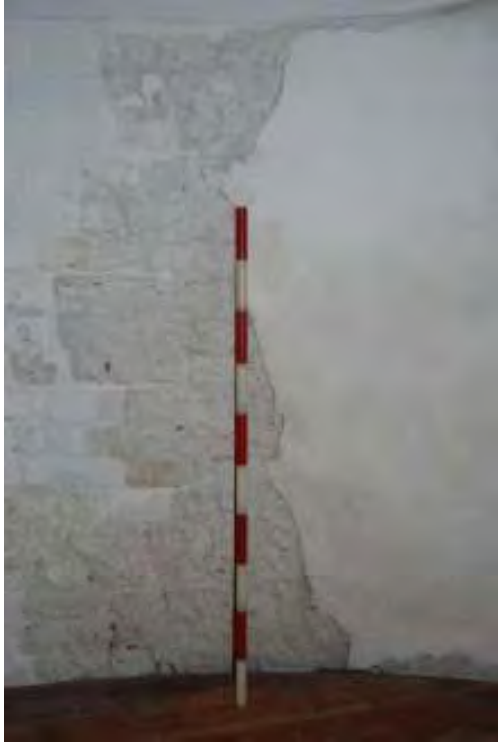
The interior walls were whitewashed during the 2010-11 restoration works, as discussed in the Southwark and Lambeth Archaeological Society Newsletter article. This was presumably for aesthetic reasons, however is patchy in places (fig.54).

Fig. 54: Photograph of the whitewashing of the interior of the walls, with the brickwork visible behind.

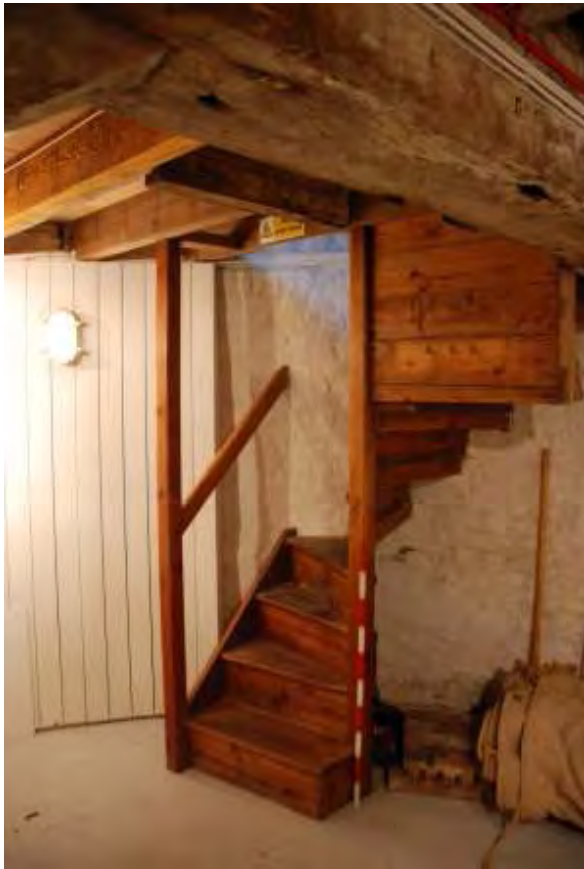
The stairs and ladders are all later insertions (added in 1964), made of machine-cut wood and conforming to modern health and safety standards (fig.57). There must have been ladders of some description in the earliest mill (possibly simple rope-ladders), although it seems unlikely that these were in their present locations. This is particularly because the eastern (original) chute leading from the second to first floor is in the same place as the present ladder - this cannot be its original position as it would have obstructed the flow of the meal. There was a possible indication of where the original ladders may have been located on the third floor, where an upright piece of timber was observed in the north-east corner c.1.1m up the wall, with a similar horizontal indent in the wall c.0.5m to the east (fig.58). This is, however, only a suggestion, and the precise locations of the original ladders cannot be ascertained, with historic plans and images providing no information.

Fig. 57: Photograph of the modern stairs leading up from the ground-floor.

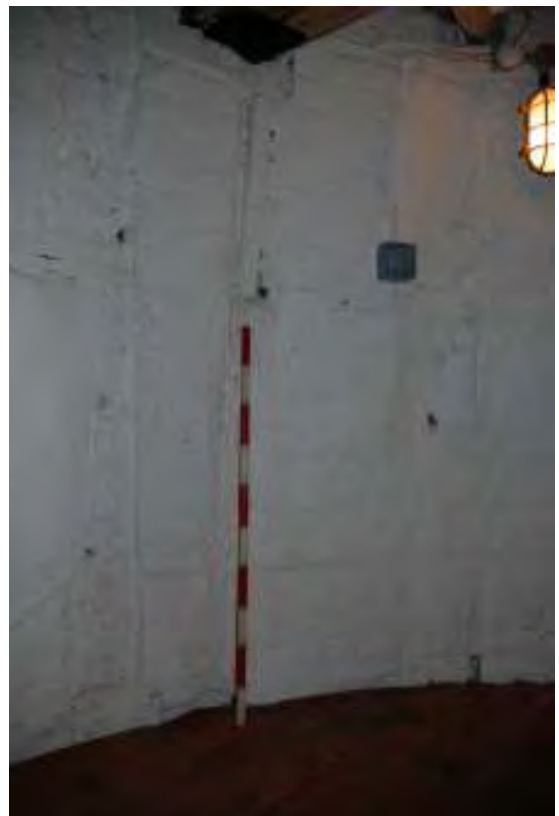
Fig. 58: Photograph of the vertical piece of timber observed in the wall on the third floor, possibly the remnant of an earlier ladder.

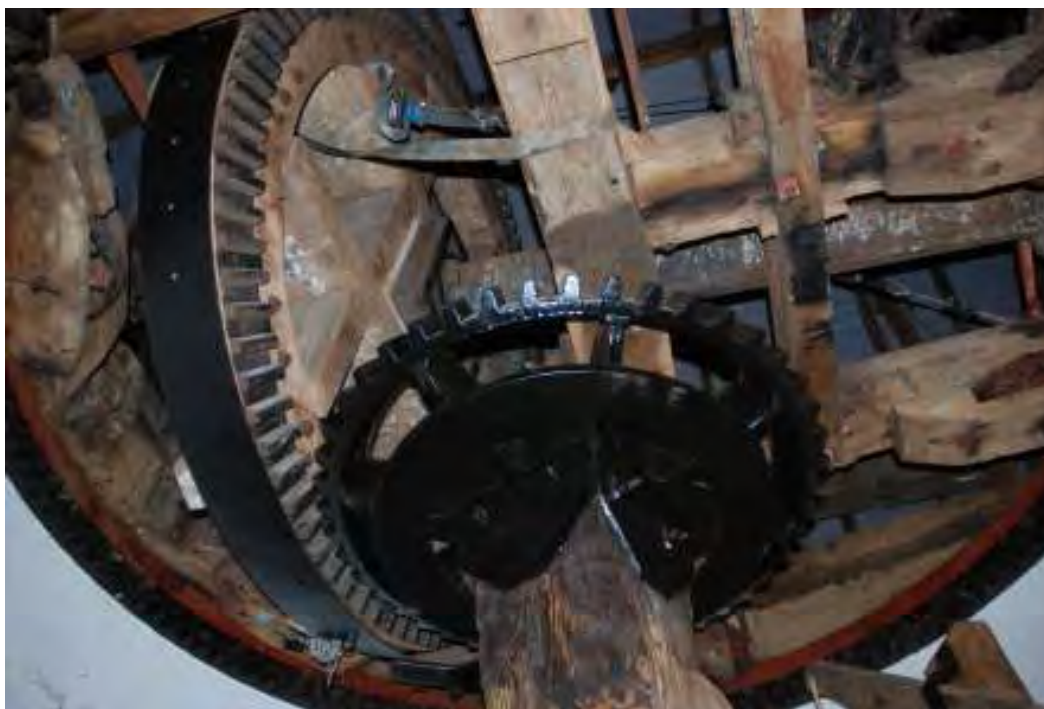
It is attached to the brake wheel (the vertical gear wheel), which would have been attached to the 'wallower' (the gear wheel set horizontally on the central vertical shaft), although it is disengaged from this today. The current 'wallower' wheel has a diameter of 1.03m and is positioned 1.95m above the floor level. This transferred the drive from the windshaft to the vertical shaft and down to the stones.

Fig. 62: Photograph looking into the cap. The wallower (the smaller horizontal wheel), brake wheel (larger vertical wheel), and windshaft (horizontal shaft at the top) can all be seen.

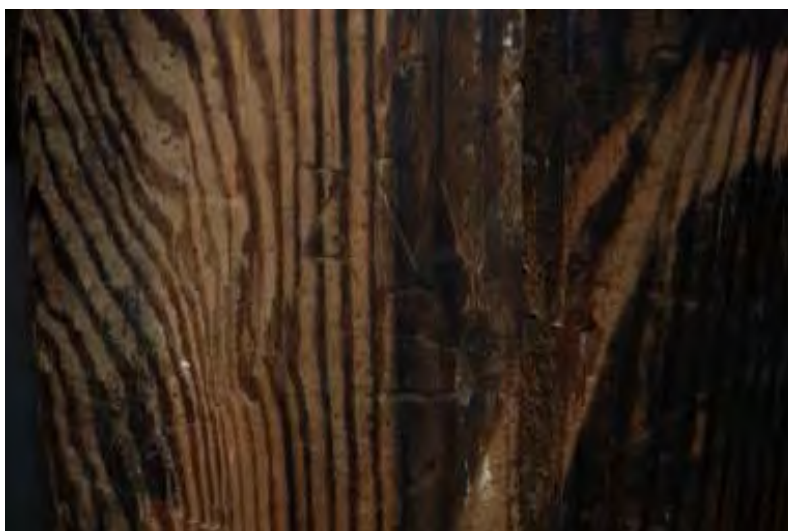
The central vertical shaft on this floor (0.32m x 0.32m) is original (as it looks older than much of the other timber, and is the same shaft as that on the floor below, which is original because of the date on it, see discussion below). This shaft carried the drive down from the sails to the millstones below. Incised graffiti marks were visible on it - reading 'Z W B'. This is a graffiti mark, not a carpenters' mark, as it contains no indications about construction.

Fig. 63: Photograph of the graffiti on the central vertical shaft.

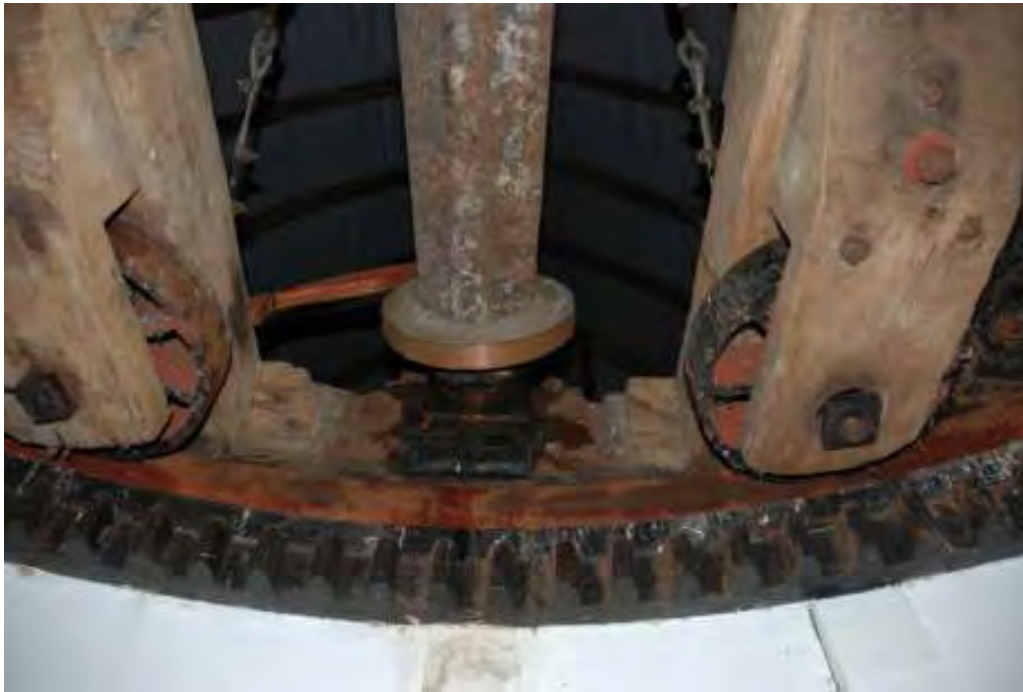
The inside of the cap is attached to the mill body via a ring of metal teeth, with six centring wheels keeping it in position horizontally. The cap would have rotated (to enable the sails to face the wind), by a wheel-and-chain mechanism driven from the first-floor stage (see section 5.6), with the mill body remaining stationary.

Fig. 65: Photograph of the iron teeth connecting the mill to the cap, and the horizontal wheels which kept the cap in position.

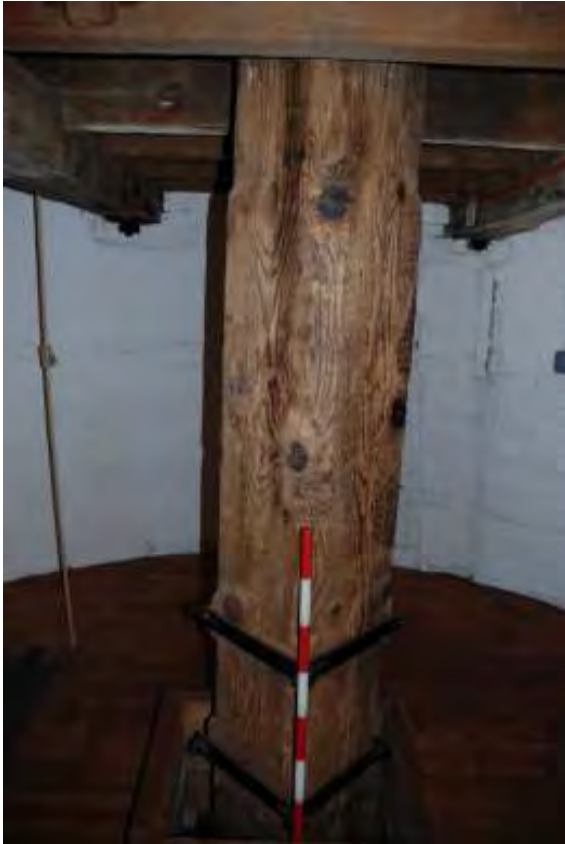
The central timber post (0.33m x 0.33m) is original (although positioned in a later machine-cut wooden box, and currently supported by iron brackets). Graffiti on it reads 'IWH 1876 1883' (dated to when the mill was being used for storage) (fig.68). This suggests that the post is original to the earliest mill, as it would not have been inserted when the mill was just being used for storage. This is a continuation of the post observed on the floor above, used to transfer the drive from the sails to the machinery below.

Fig. 67: Photograph of the central vertical shaft, used to transfer the drive down from the sails.

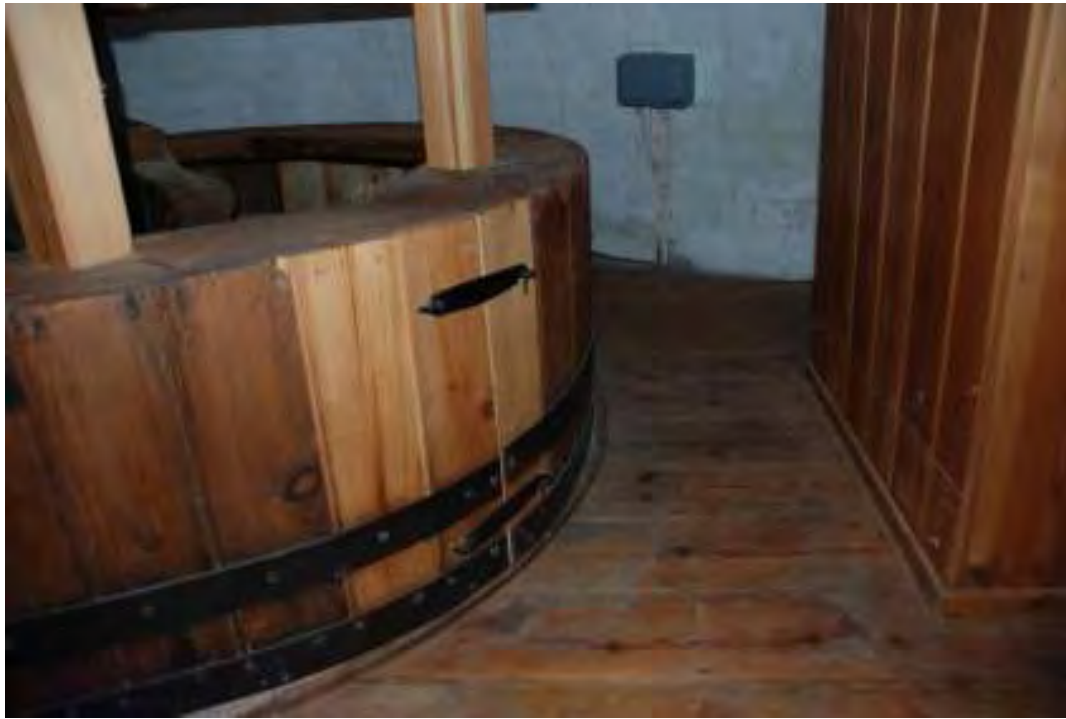
The drive passed through these wheels to the millstones, situated within the circular wooden vat (inserted in 1964; 1.48m in diameter and 0.42m in height) (fig.72). It contains both millstones: the upper 'runstone', which rotated, and the lower 'bedstone' which remained stationary. The present stones are from Derbyshire, and have grooves on their inside faces to grind the grain. These stones are used for grinding barley, in contrast to French burr stones which were used for finer grinding. Above this is the wooden hopper (into which the grain was fed), which is 0.51m in height, 0.65m x 0.65m at its top, narrowing to 0.12m x 0.12m at its base. This fed the grain into the 'shoe', which shook the grain into the millstones at a steady pace (fig.73). The grain, once ground, would have exited the vat from one side - this area is currently latched up (fig.74).

*Fig
. 74:
Ph
oto
gra
ph
of
the
vat,
sho
win
g
the
are
a
whi
ch*

would have been open where the meal would have exited.

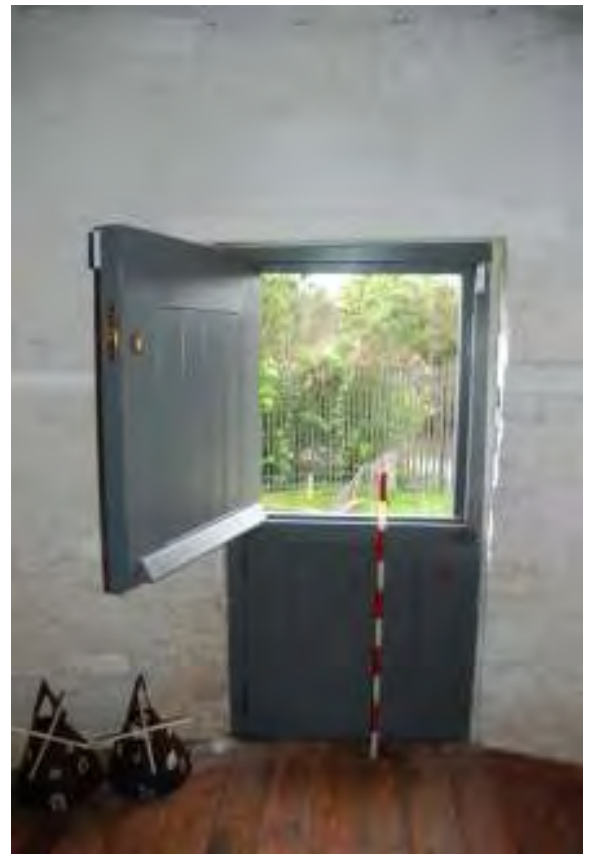
The two doors on this floor (the functioning one on the southern side (fig.82) measuring 2.11m in height, by 0.86m in width; and the blocked one on the northern side (fig.81) measuring 2.18m in height by 0.86m in width) represent the location of the original doors which accessed the first-floor level stage (see section 5.4).

Fig. 82: Photograph of the door on the southern side of the structure.

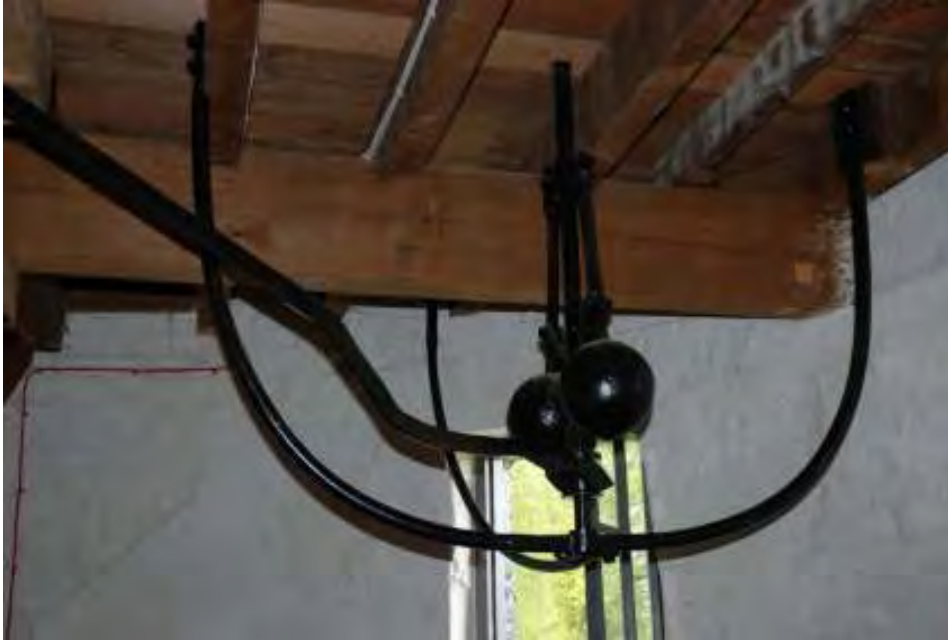
The 'governor' was inserted in 1964, although it reflects what would have existed in the mill's wind-powered phase. It controlled the distance between the two millstones to ensure the consistency of the meal being produced, as the runner stone would typically rise whilst grinding. The governor rotated (driven from above, see section 6.4), which drove the balls outwards (by centrifugal force), which drove levers and gears which were connected to the runstone (figs.83-84).

Fig. 83: Photograph of the governor.

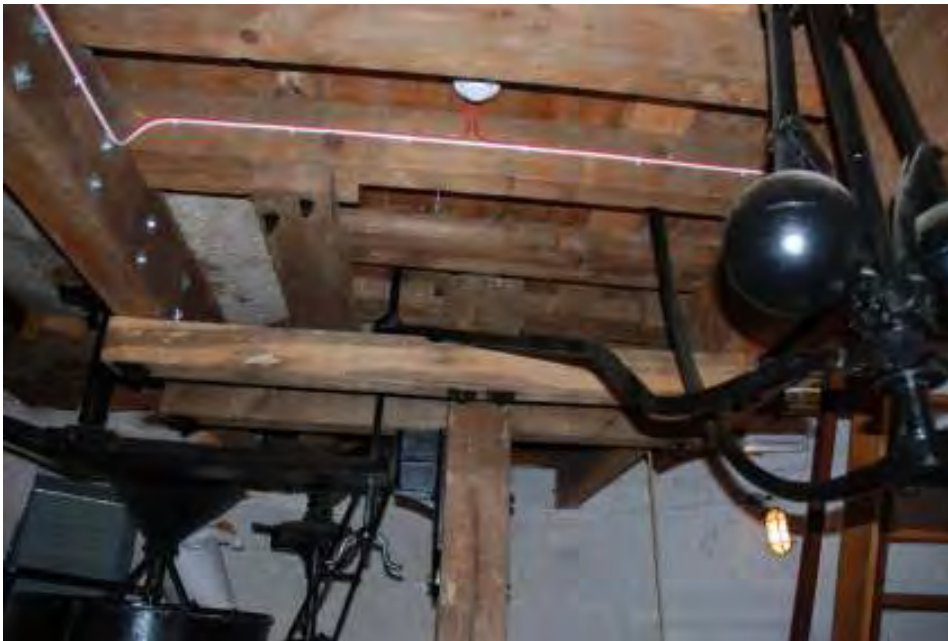
Fig. 84: Photograph showing the governor, and series of levers connecting this to the base of the millstones.

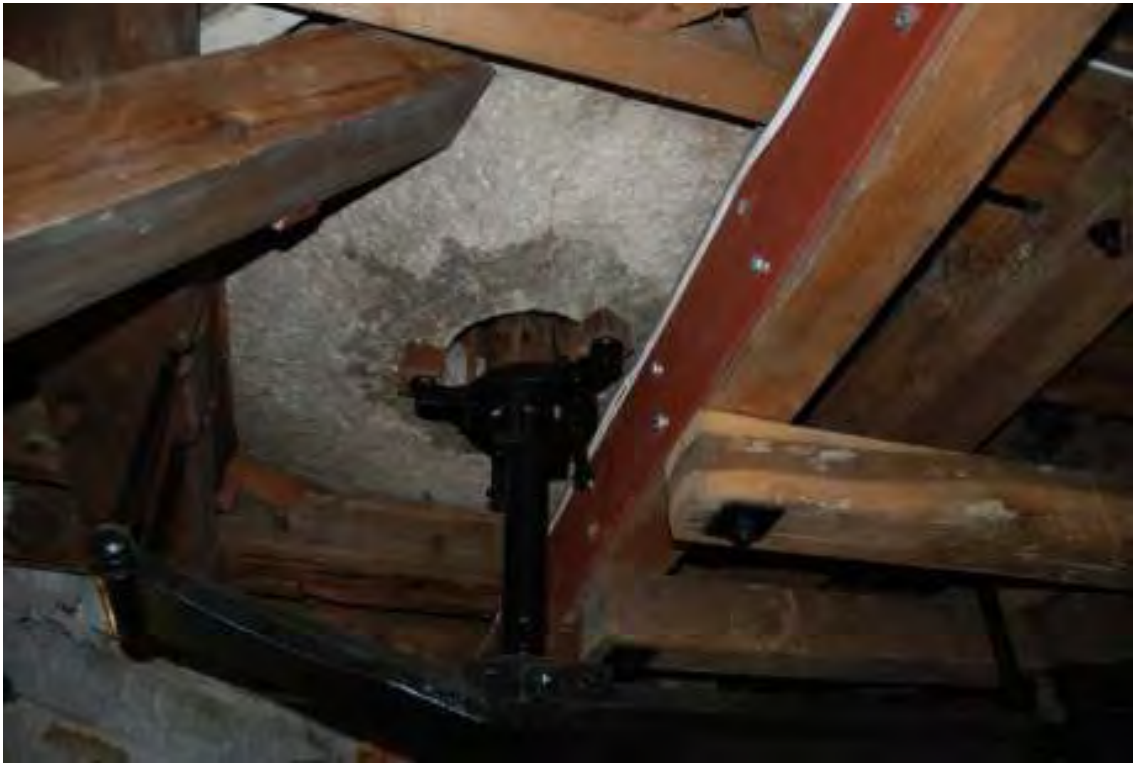
The bottom of the bedstone could be seen from this floor (fig.85). The wooden chute, coming from the floor above, through which the meal would have passed, was also observed (fig.86). This is all replaced (in 1964), but reflects what would have originally been here.

Fig. 85: Photograph of the bottom of the bedstone, viewed from the floor above, and the levers attached to the governor.

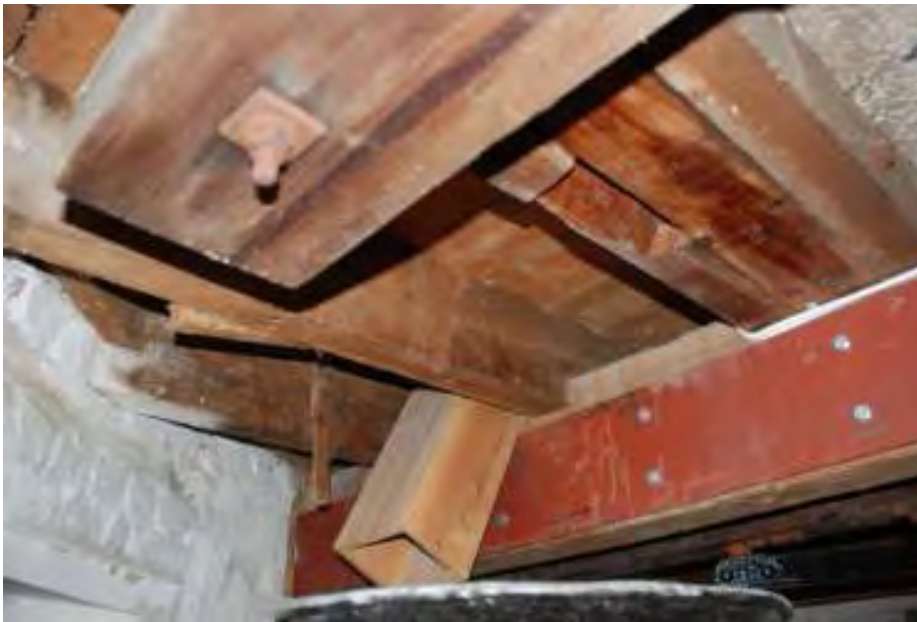
Fig. 86: Photograph of the (replica) wooden chute which would have brought the meal down from the floor above.

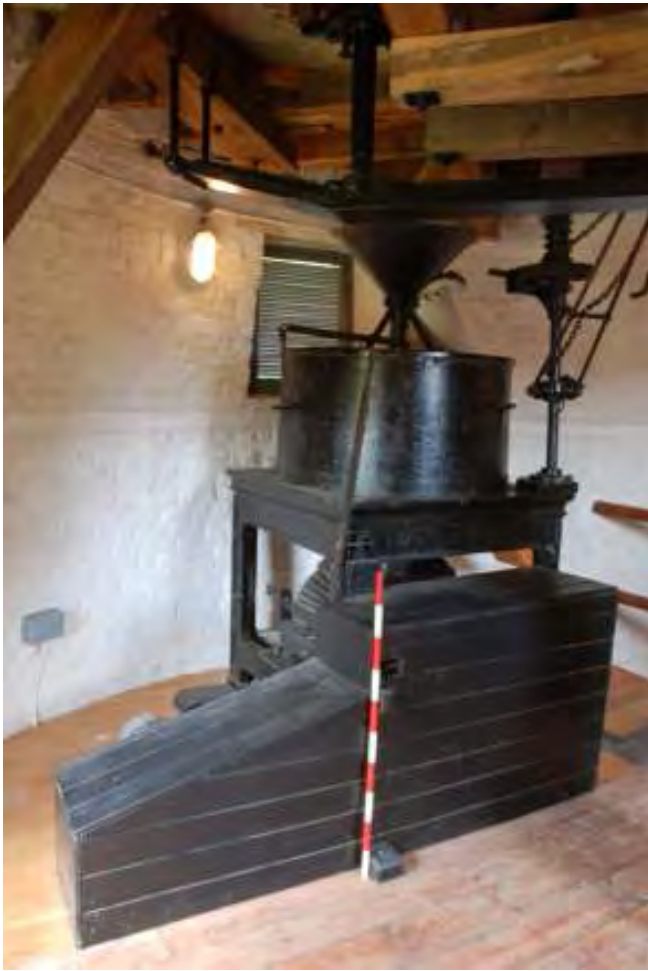
The provender mill (driven by steam / gas) is also on this floor (fig.87). This was inserted in 1902 when the mill became driven by steam (and then gas), however it was heavily renovated during the 1964 and 2010-11 works and is now driven by electricity. The metal 'chute' into which the grain was fed is visible, plus the metal drum (inside which the millstones could be seen), and the two gear-wheels which turn them (figs.89-90). These are driven from the fan-belt, currently powered by electricity.

Fig. 87: Photograph of the provender mill.

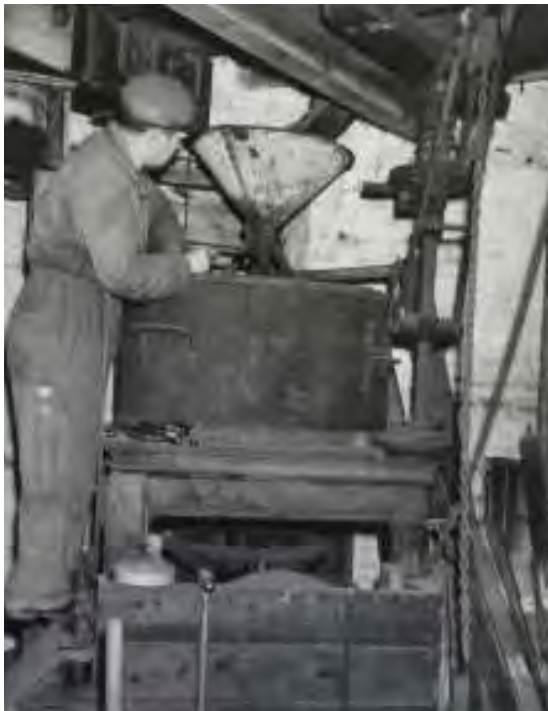
Fig. 88: Photograph of the restoration of the provender mill in 1964 (LMA).

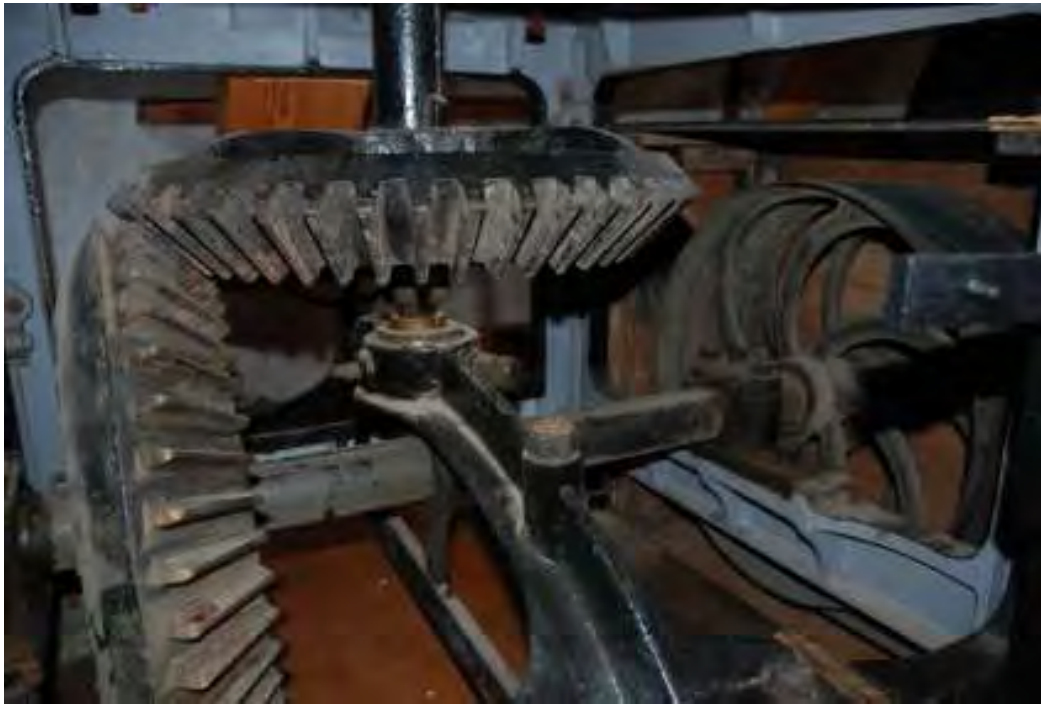
Fig. 89: Photograph of the interior of the provender mill, showing the fan belt (right of image) which is currently driven by electricity, connected to two gear-wheels which rotate the millstones.

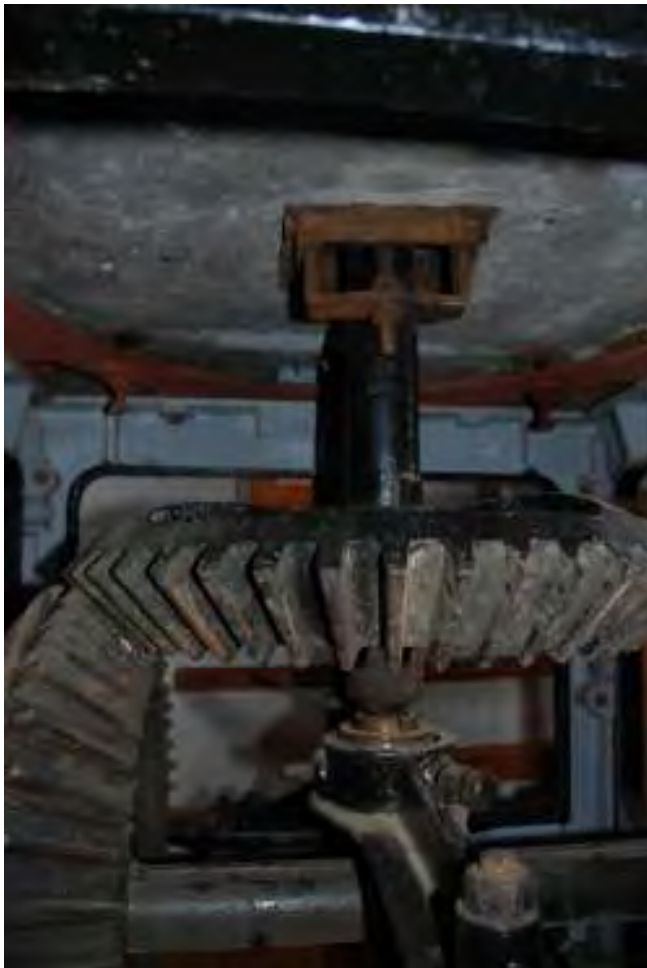
Fig. 90: Photograph of the interior of the provender mill, showing the two gear-wheels attached to the millstones.

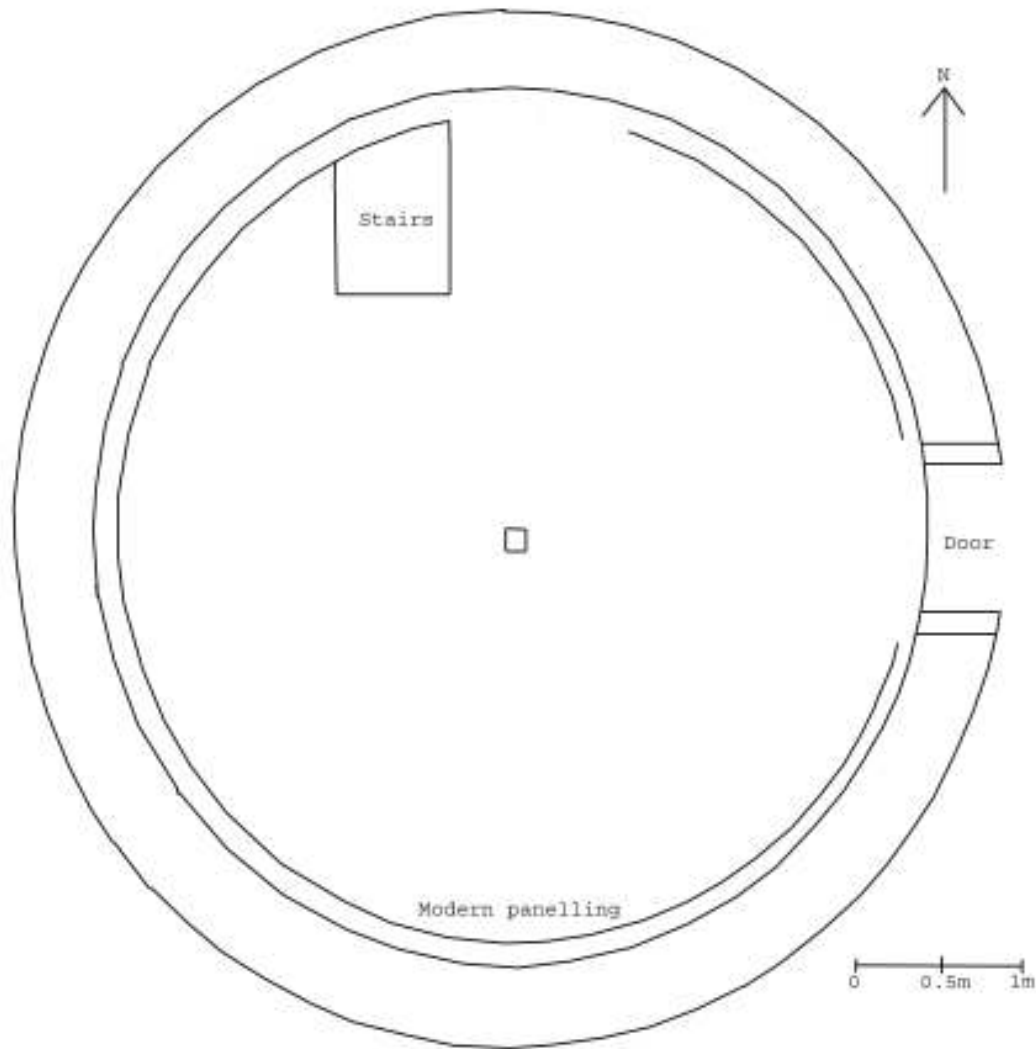
The ground-floor is used for educational purposes and visitors today, accounting for many of its features (inserted during the 2010-11 renovation works). The diameter is *c.*5.35m, with a floor to ceiling height of *c.*2.24m.

Fig. 91: Plan of the ground floor, depicting the main features that are found there today.

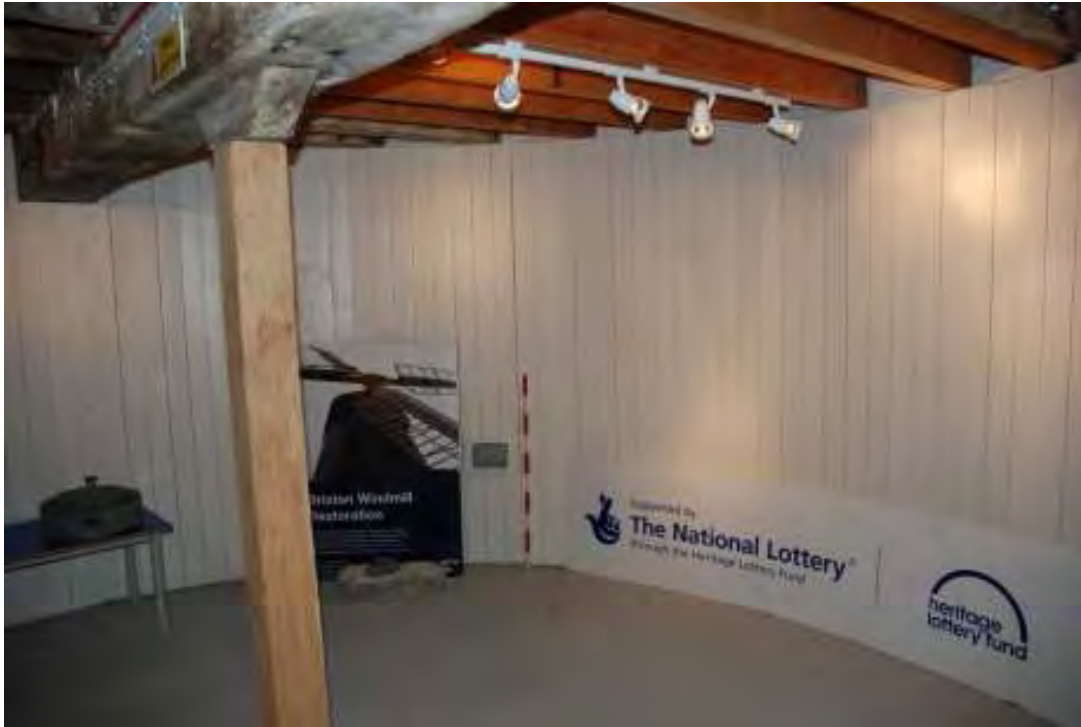
Most of the room is covered by modern white timber panelling (2.10m in height and 0.18m in thickness). Displays and signs cover these, plus lighting and alarm controls (fig.92).

Fig. 92: Photograph of the ground-floor of the mill today, showing the modern plasterboard and signs.

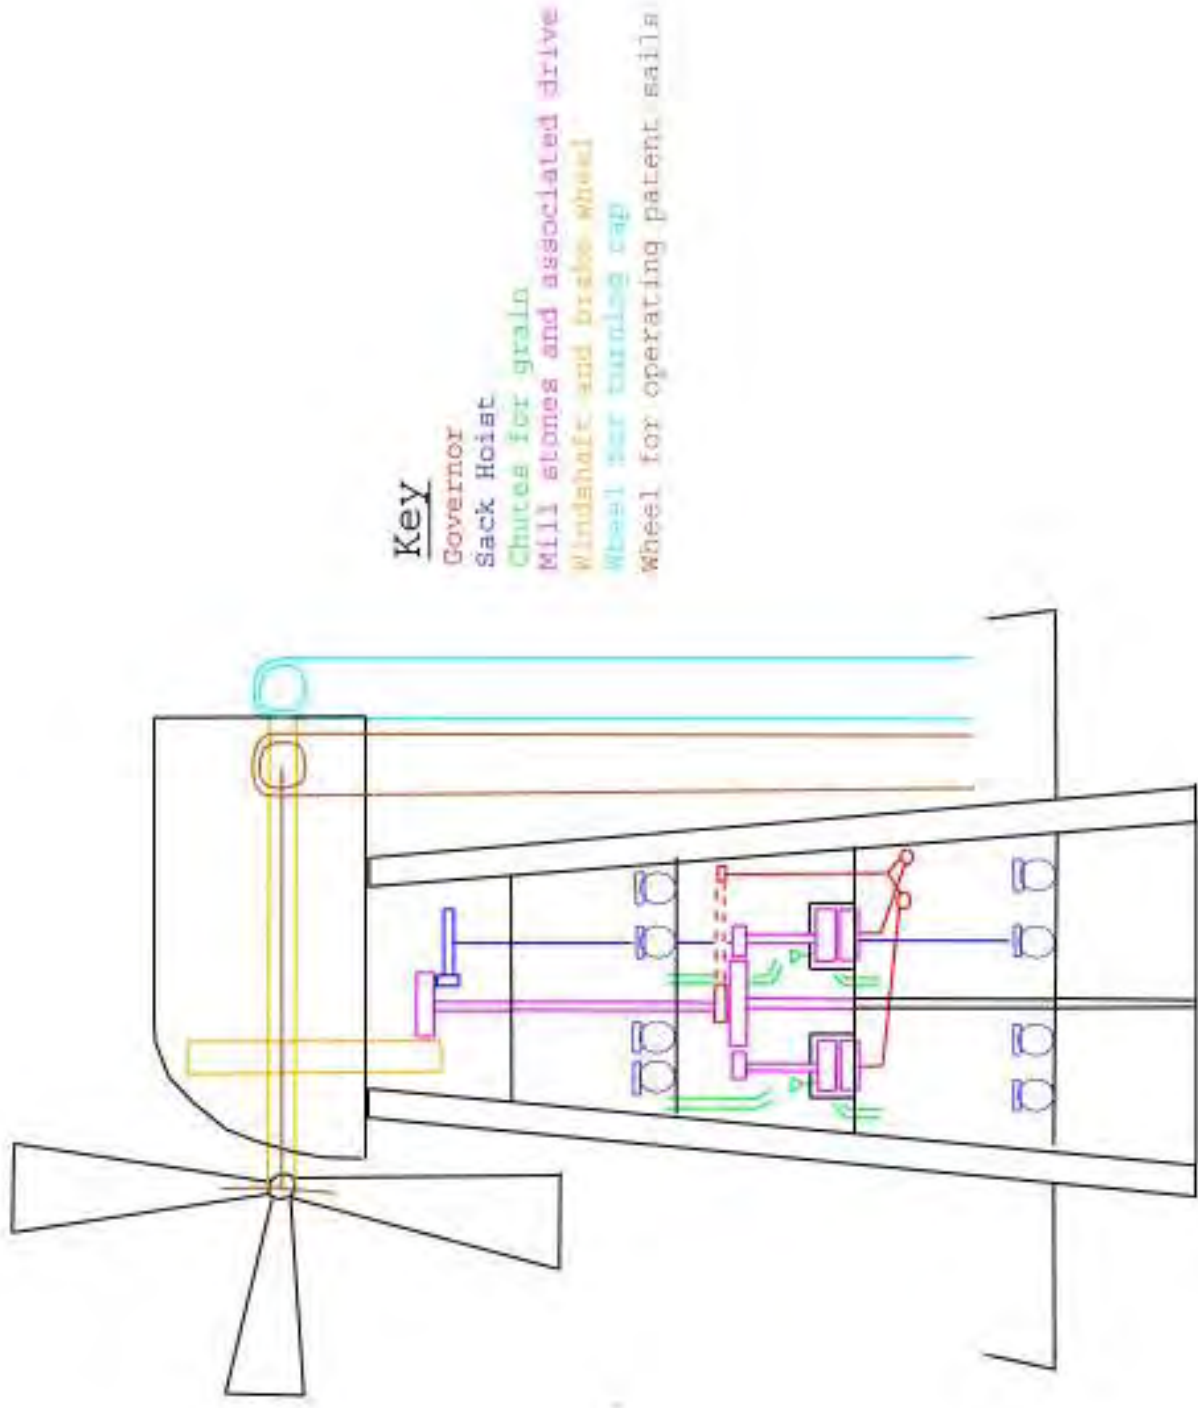
Fig. 95: Schematic elevation of Brixton Windmill, showing it as it is believed it looked in its original wind-powered days.

The first stage of the process involved the turning of the sails, driven by the wind. There were two pairs of sails - initially both were common sails until 1827 when one pair was converted to patent sails (William Ashby's ledgers record this). These patent sails were operated via a wheel-and-chain mechanism (brown in fig.95), which led to a stage, from where they could be operated. Another wheel-and-chain mechanism turned the cap (turquoise in fig.95), to move the sails into the wind.

The sails were attached to, and turned, the windshaft (the large horizontal shaft leading off from the sails into the mill itself) (orange in fig.95). This was attached to the brake-wheel (orange in fig.95), which engaged with the wallower to transfer the drive from the sails to the vertical shaft. The drive from the wind was thereby transferred down the mill structure via this vertical shaft, to the second floor (purple in fig.95).

On the second floor two gear-wheels (the spur wheel and stone nut) drove the millstones, with the upper stone (the runstone) rotating, whilst the lower stone (the bedstone) remained stationary (purple in fig.95). The grain was fed to the stones via the hopper and shoe, was ground by the stones, and exited the vat through one of its sides and down chutes to the floor below (green in fig.95). The distance between the millstones was controlled by the governor, which used levers to lower the runstone when necessary (red in fig.95).

The grain was stored in sacks on the ground-floor. This was raised up to the third-floor (through various trap doors) using the sack hoist (positioned on the fourth floor), which was driven by friction from the wallower wheel (blue in fig.95).
